Meeting AGENDA

Depot and Westminster Street Capacity
Evaluation

Re: **Depot and Westminster Street Wastewater Capacity Evaluation**

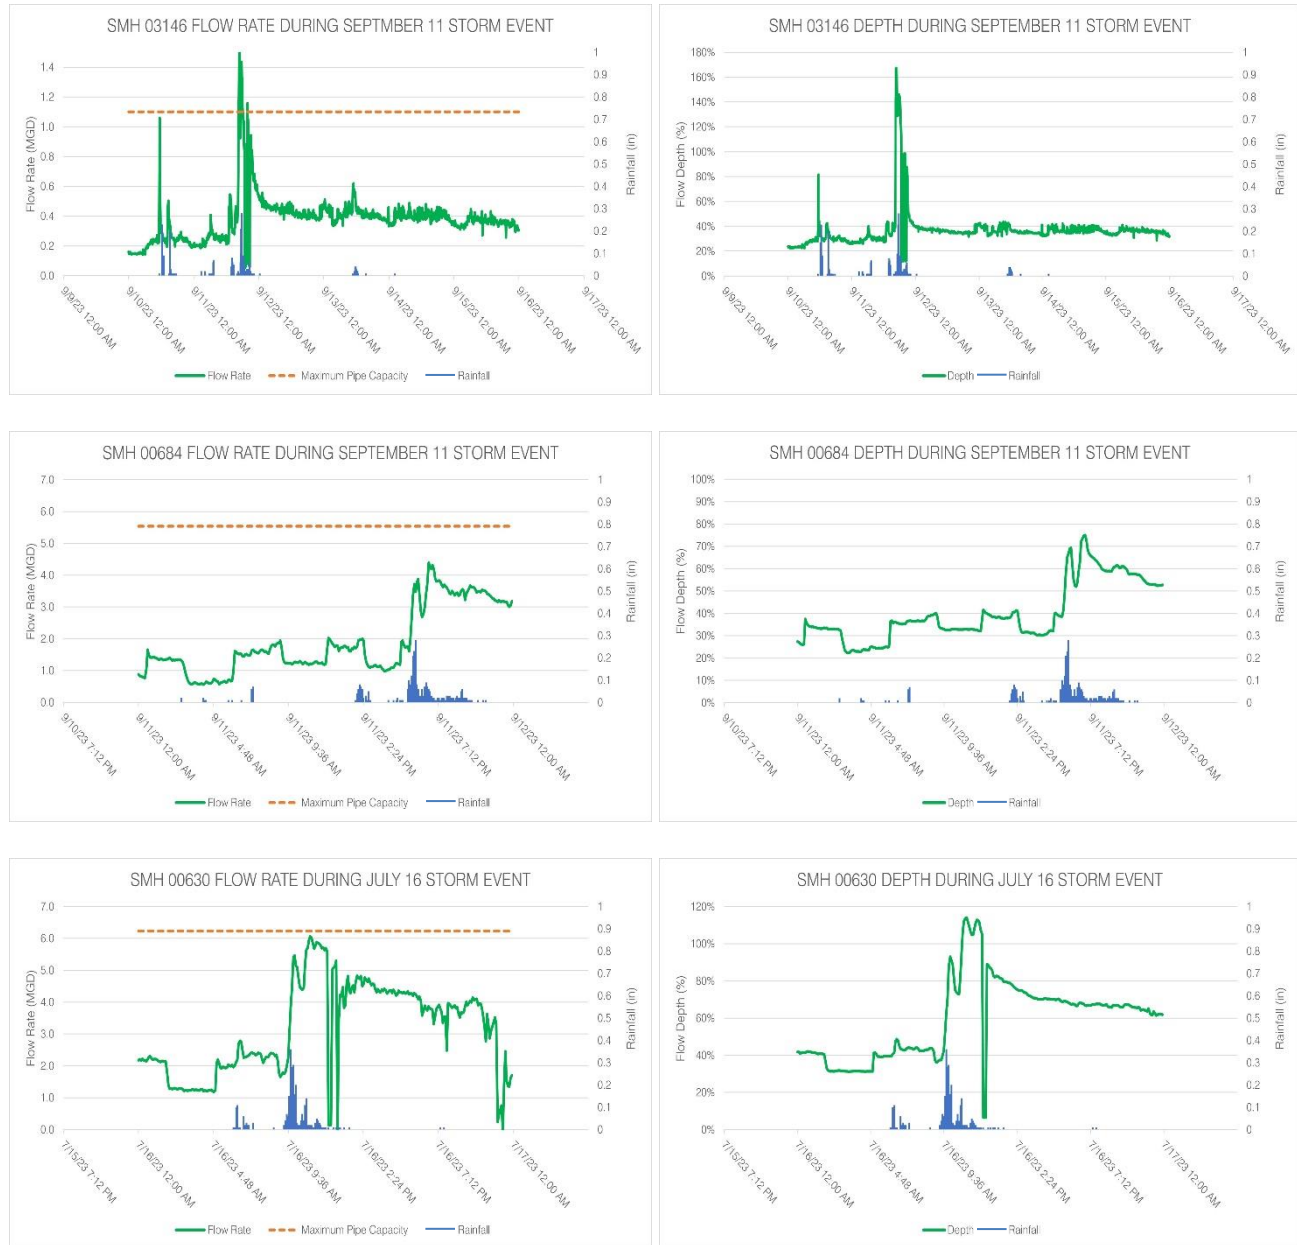
The most significant increase in flow rate at each meter and the associated rainfall events are shown in the following graphs:

The most significant readings observed during these storm events were the depth and flow rate in SMH-03146 on Depot Street. During the September 11th, 2023 rain event, pipe flows were recorded well above 100% capacity. The significant inflow that occurred on Depot Street may be due to the seven (7) remaining combination manholes upstream. It should be noted that the sudden isolated dips in flow rate and depth in SMH 03146 and SMH 00630 may be erroneous readings. Graphs of wastewater flow during major storms event are provided in Appendix C.

A map of the meter locations is shown in Figure 3. During the flow metering timeframe of October 19th, 2022 and January 11th, 2024, two (2) major storm events resulted in the most significant increases in wastewater flow. Flow Meters 03146 and 00684 observed the largest increase in flow on September 11th, 2023, while Flow Meter 00630 observed the largest increase in flow on July 16th, 2023, as shown in the table on the following page:
